PUNCTATE BASOPHILIA AND LEAD ABSORPTION

By S. F. M. Cressal, M.A., B.M., B.Ch., D.P.H.
(I.L.O. Occupational Health Adviser)

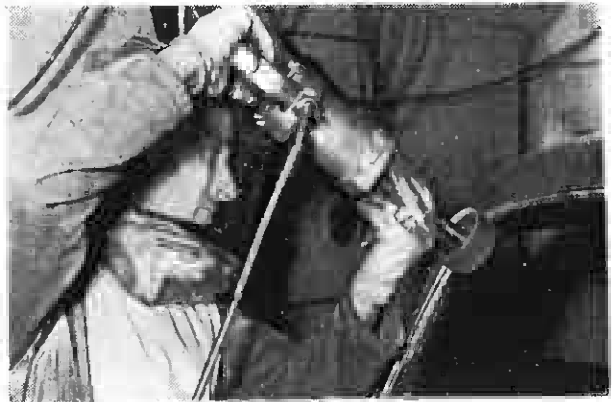
Figure 7.

These patches are covered over with solder, a tin and lead mixture (Fig. 5), and ground smooth where practicable by filing (Fig. 6), which does not produce any fine dust. In some awkward corners grinding machines have to be used (Fig. 7). These produce dust particles less than 5 microns in diameter, a respirable lead hazard. Solder application is not dangerous. Whereas the melting point of lead is 618°F with little fume until a higher temperature, solder is workable at 450°F.

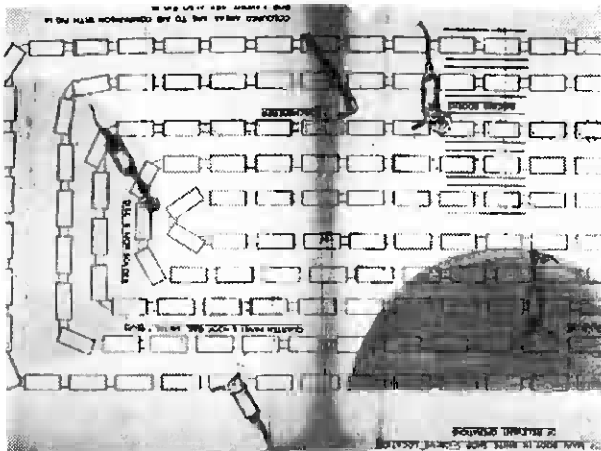
Figure 8.

A shop plan of the flow of production show two areas where solder machine grinding occurs (Fig. 8). While the car body moves down the conveyor lines, assembly and metal finishing are performed, and solder patches applied. Originally full time grinders worked behind screens at one end of the shop wearing filter respirators. Further down the line in the touch-up area, final metal finishing is done to the entire surface, including solder patches; minor defects may be removed by repair solderers.

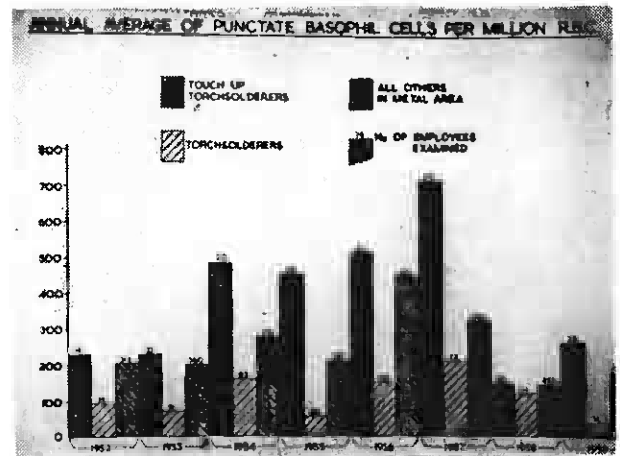
Figure 9.

Men from these two areas were examined periodically using punctate basophil and haemoglobin checks, so also were the men applying solder. A chart (Fig. 9), showing the latter's average basophil count over several years compared with the average of the shop is evidence of low lead absorption, although the few torch solderers on repair work in the touch-up area show a higher average.

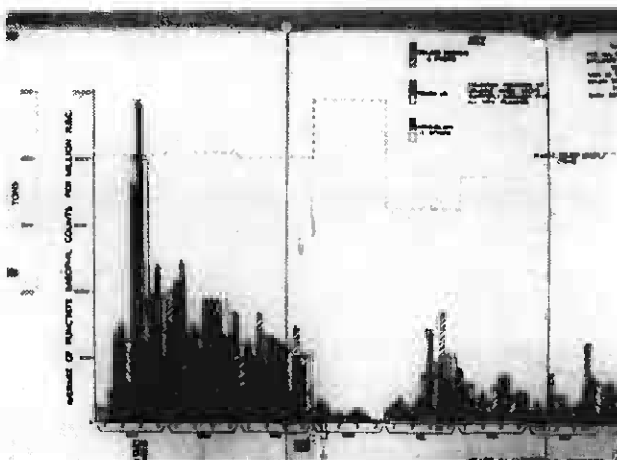
Figure 10.

Another chart (Fig. 10) shows the average for all the workers in the shop over a period of 12 years, recorded for each quarter. Within the broad column showing this, are three narrow columns which show the average of the men in the two danger areas, and all others in the shop.

The hazard had been known pre-war but on resuming peace time manufacture, rules had been forgotten. A case of lead poisoning occurred, and it was found that the average punctate basophil count was high. Discipline was tightened up and for some years there were no further cases, the average count remaining low.

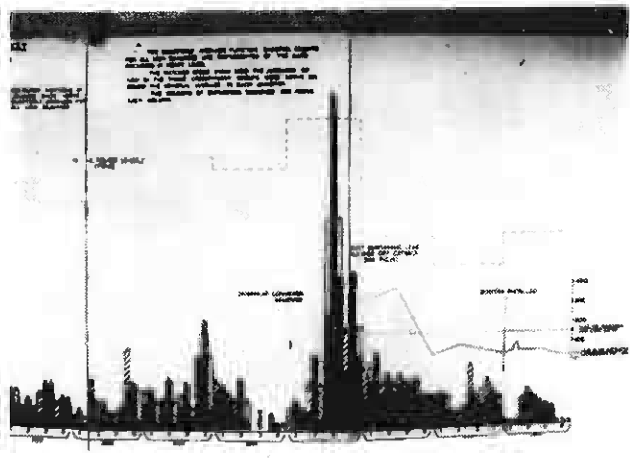
Figure 11.

Suddenly, in the third quarter of 1956 it rose (Fig. 11). There was no increase in overtime, neither the number of solder patches nor the speed of the line had increased, nor the working position of operators changed.

The high counts were around the touch-up area: the average had been above general shop level here on previous occasions, men had temporarily been removed from this area, when repair work had increased with the introduction of a new model. This time there was no such reason for an increase far greater than before.

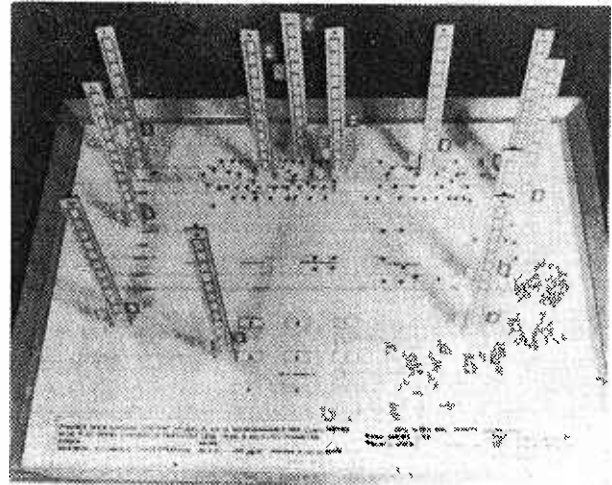
Figure 12.

Air analyses were done for lead in particles less than 5 microns, which showed atmospheric contamination corresponding to the area of high counts (Fig. 12). A thick deposit of fine dust was found on some roof trusses and catwalks. Analysis revealed lead content of 11%. Some months before there had been a reorganisation of cleaning responsibility. No one had cleaned this small area. Footprints showed much dust had been kicked off by men

working near the roof shortly before. After many months accumulation it had fallen down on the touch-up men who had sporadically produced it.

Due to a minor breakdown in housekeeping a dangerous situation had occurred after several uneventful years. The danger was spotted in time to prevent cases of frank lead poisoning. However, efforts were made to confine future discing inside booths where exhaust ventilation would stop any further drifting dust. Periodic sampling was done outside booth openings to make sure the system was working.
