**UROLITHIASIS ON NON-ABSORBABLE SUTURE MATERIAL: A RARE CASE OF BLADDER STONE ON POLYPROPYLENE SUTURE MATERIAL**

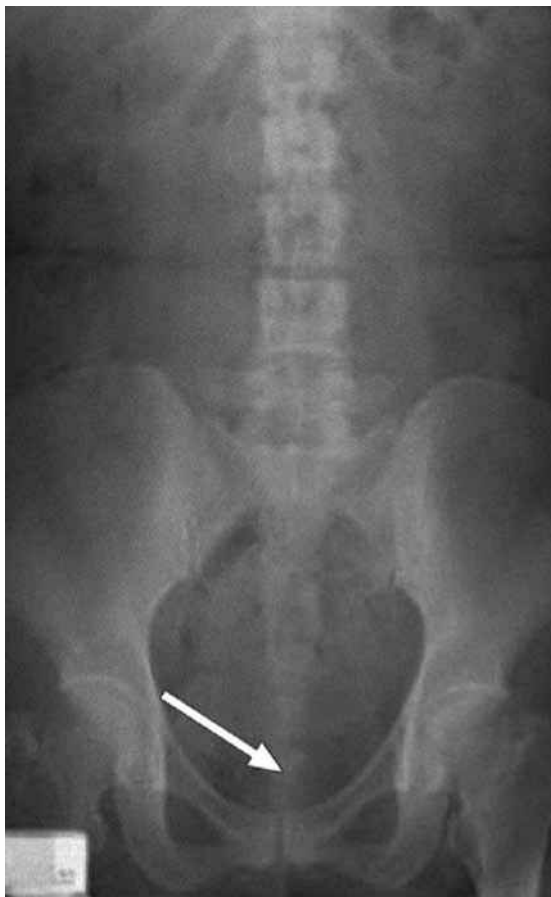
**Fig. 1** Kidney ureter bladder radiograph shows a bladder stone (arrow).

A 59-year-old woman had a hysterectomy for myoma uteri six years ago. She visited our outpatient clinic with complaints of dysuria, suprapubic pain and gross haematuria for several days. We performed a physical examination as well as laboratory and radiological evaluations. The urine test demonstrated significant cristaluria and microscopic haematuria. In the kidney ureter bladder radiography examination, a milimetric opacity at the bladder zone was observed (Fig. 1) and ultrasonography revealed an echogenity at the roof of the bladder (Fig. 2). In the light of these findings, we reached a diagnosis of bladder stone and scheduled a cystoscopic evaluation.

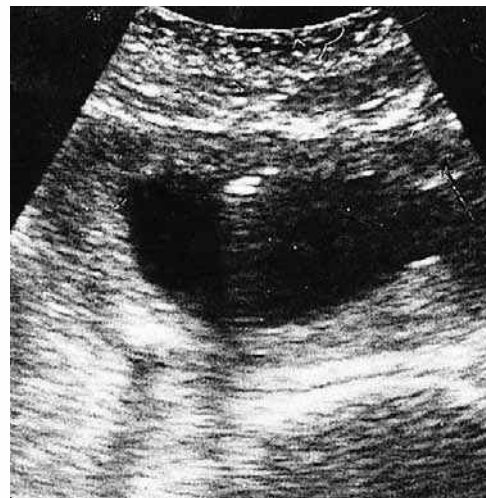
**Fig. 2** US image shows echogenity at the roof of the bladder.

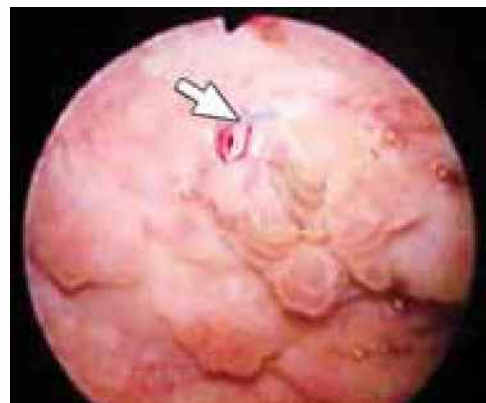
**Fig. 3** Endoscopic image shows the polypropylene suture (arrow).

After endoscopic disintegration of the stone, endoscopic lithotripsy was performed with a pneumatic lithotripter. Following lithotripsy, a non-absorbable suture was seen (Fig. 3). Endoscopic resection was performed, and the non-absorbable suture was resected using a 24F resectoscope. The patient was discharged on the Day 3 post surgery with a urinary catheter, which was removed on Day 7 post surgery.
