# Late complications of spontaneous urethral erosion of malleable penile prosthesis in a young patient

*Keywords: complication, erectile dysfunction, penile prosthesis, urethral erosion*  
*Singapore Med J 2012; 53(6): e120–e121*

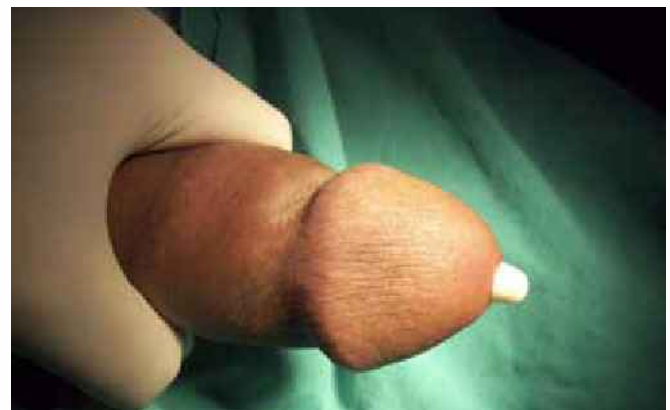
**Fig. 1** Photograph shows the tip of the left-sided penile prosthesis through the fossa navicularis of the meatus urethra.

On physical examination, erosion of the left penile prosthesis was demonstrated through the fossa navicularis of the distal urethra, while the right side was safe in an intact corpora cavernosum (Fig. 1). As extraction of the prosthesis could not be managed at the outpatient clinic, the patient was hospitalised. The 24-cm, left-sided malleable penile prosthesis was extracted under regional anaesthesia with a subcoranal incision (Fig. 2). An approximately 45-degree curve deformity was noted on the extracted prosthesis. No erosion was noticed on the contralateral side, and re-implantation was not done for the ipsilateral side at the same session. Although pre-operative urinary culture was negative and there were no findings suggestive of infection in

In cases of urethral erosion of the malleable penile prosthesis, the rods protrude from the urethra, and thus, extraction from the urethra as a simple office procedure has been suggested.<sup>(1-3)</sup> However, in our case, simple extraction could not be managed in the outpatient clinic and the patient underwent extraction with a corporotomy under regional anaesthesia. One possible reason for our failed attempt with simple manoeuvres could be that the rod had integrated with the neighbouring tissue in the course of the past two decades. To support this theory, subsequent forced extraction of the prosthesis was required during the procedure at the operating theatre. We did not consider replacement of the prosthesis, as there was a possibility of infection, and the contralateral side was intact. One-sided intact rods have been reported to be sufficient for adequate coitus.<sup>(4)</sup> The extracted prosthesis had a spontaneous bending deformity at about 45 degrees, which could be due to the deterioration of the prosthetic material. Interestingly, the patient did not mention any sexual problem associated with it.

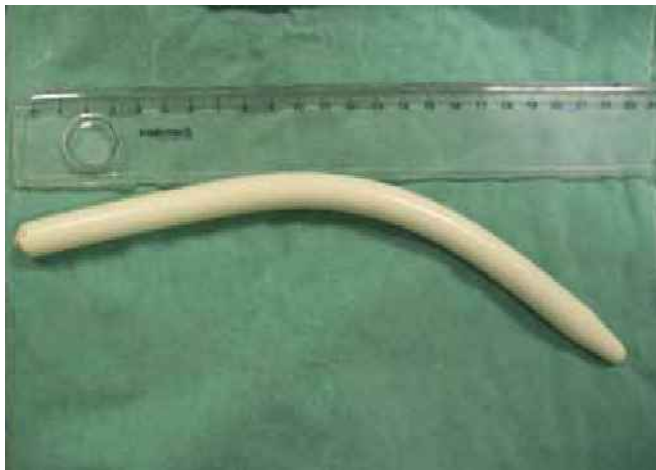
**Fig. 2** Photograph shows the extracted 24-cm malleable penile prosthesis with a spontaneous curving deformity, possibly occurring intracorporeally during the past 23 years.
